Performance Evaluation of Entry Doors

By: Elie Alkhoury, M.Eng. (Building Science), P.Eng.

November 2003

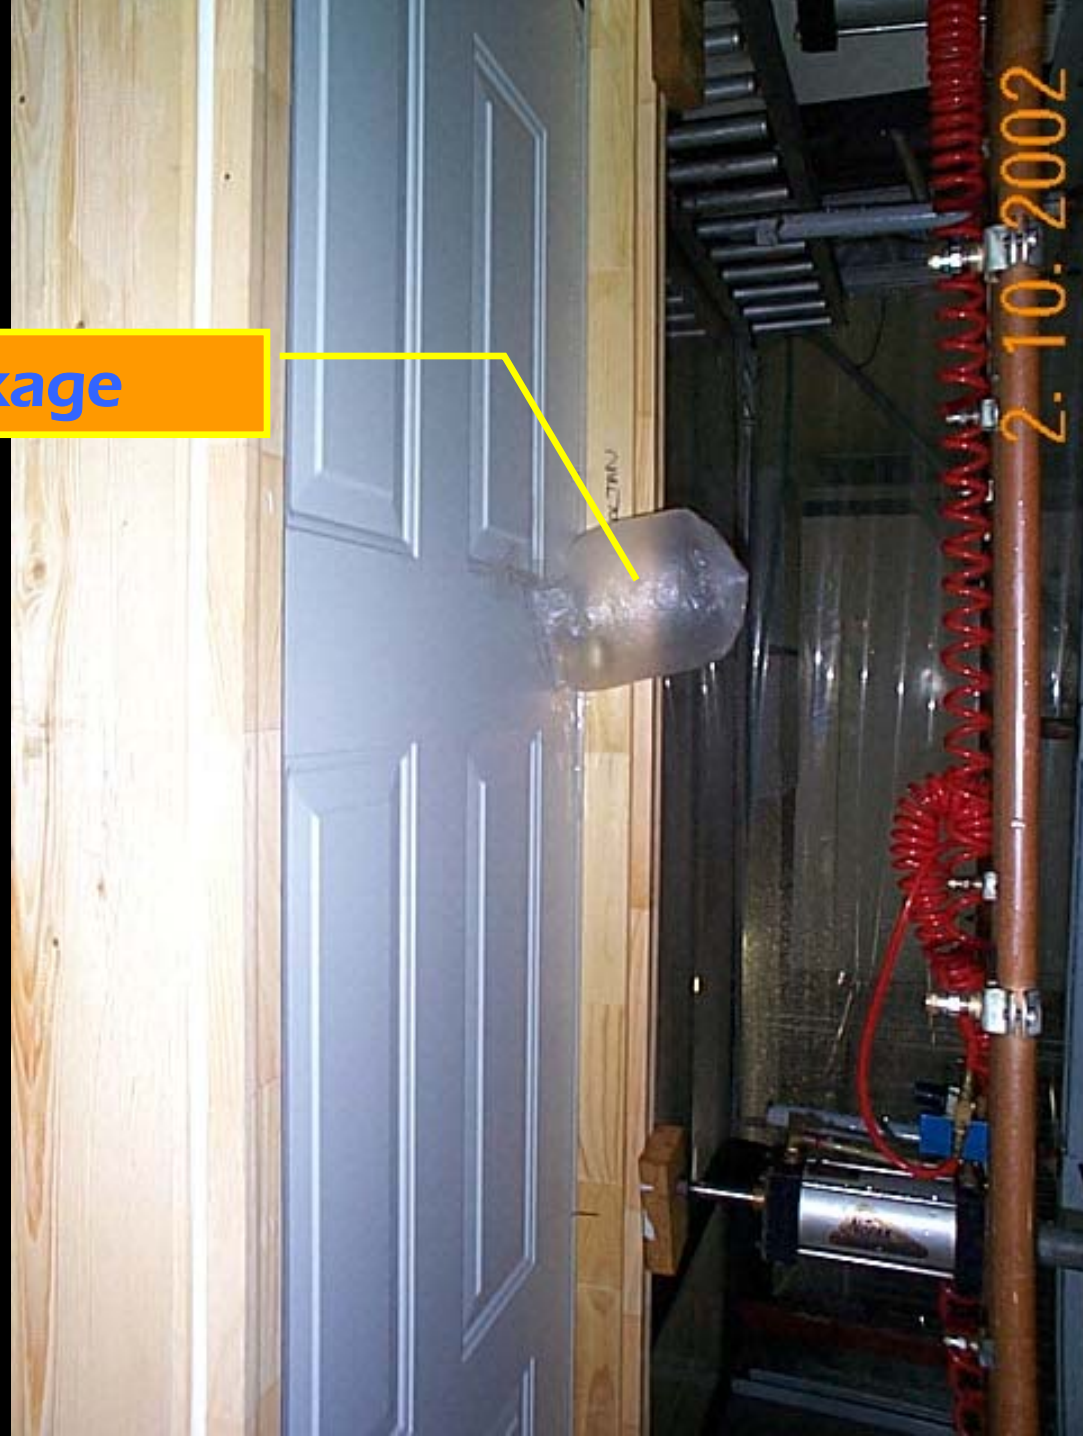
Air Leakage

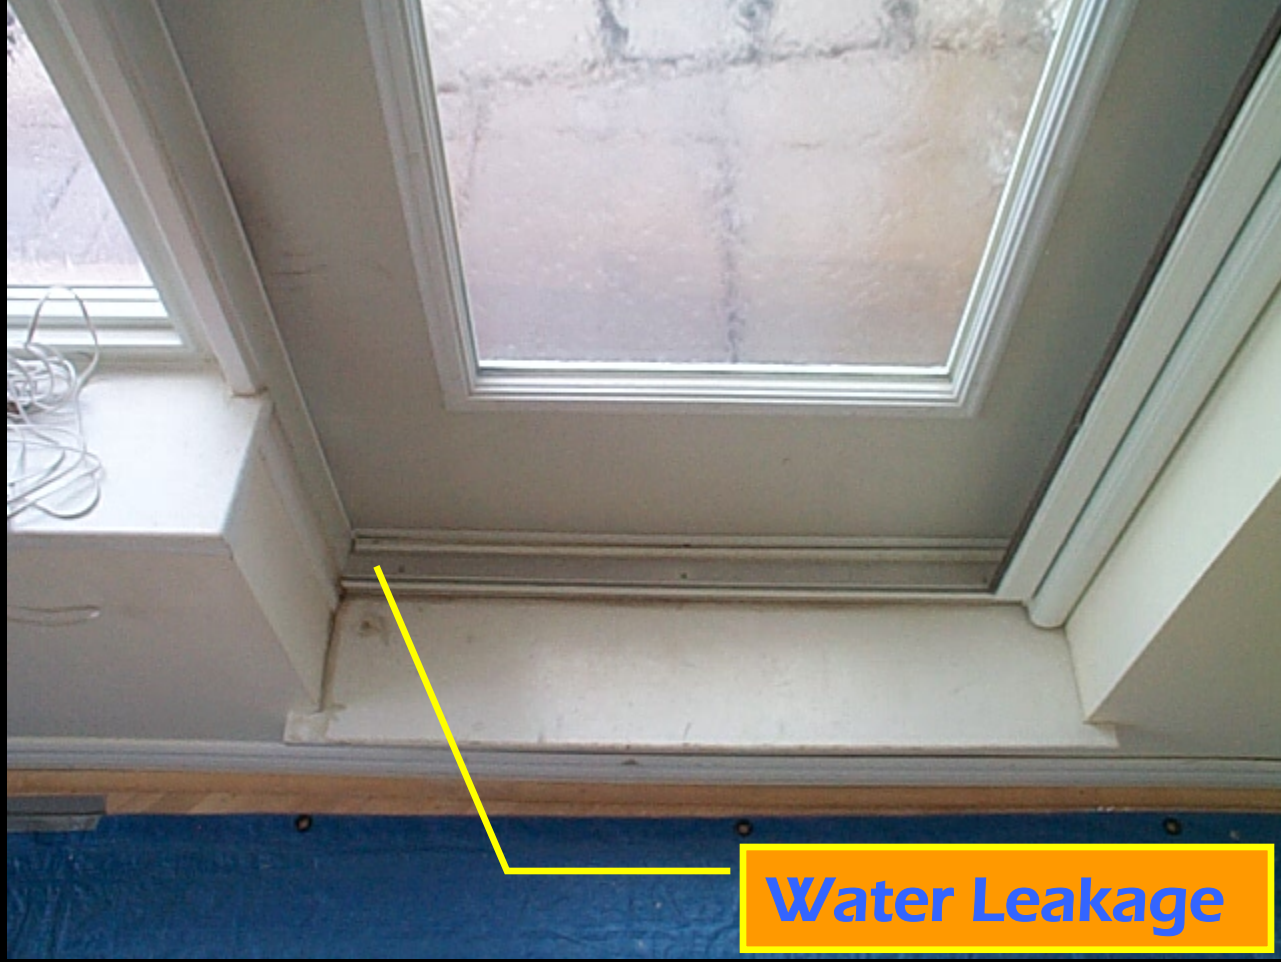
*Here's a typical water penetration test carried out for **five minutes at 0 Pa:***

Water Leakage

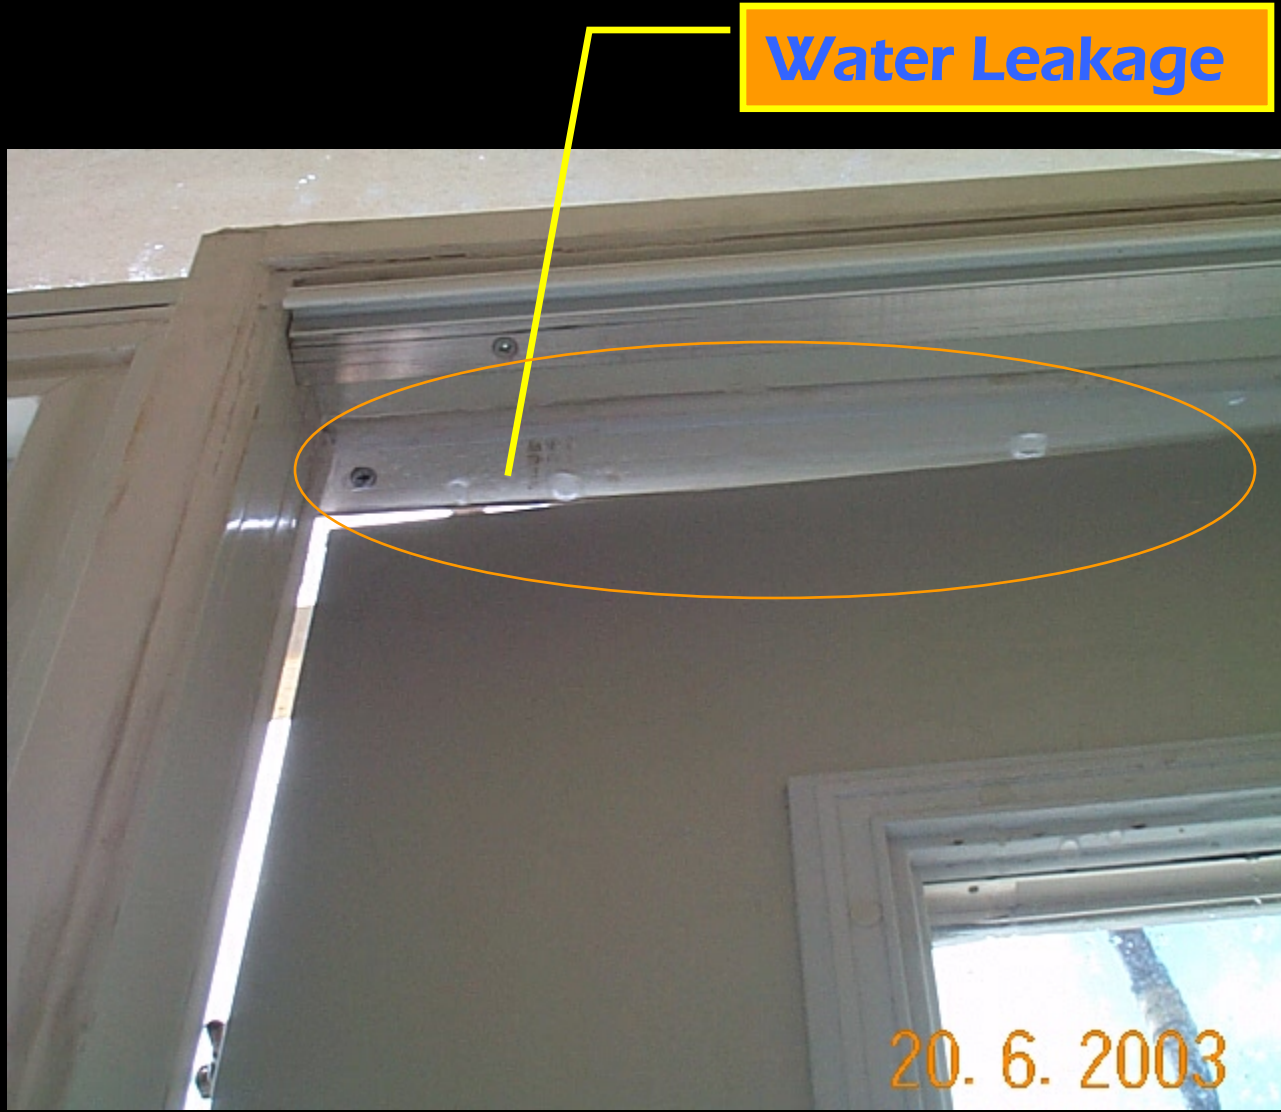
Water Leakage

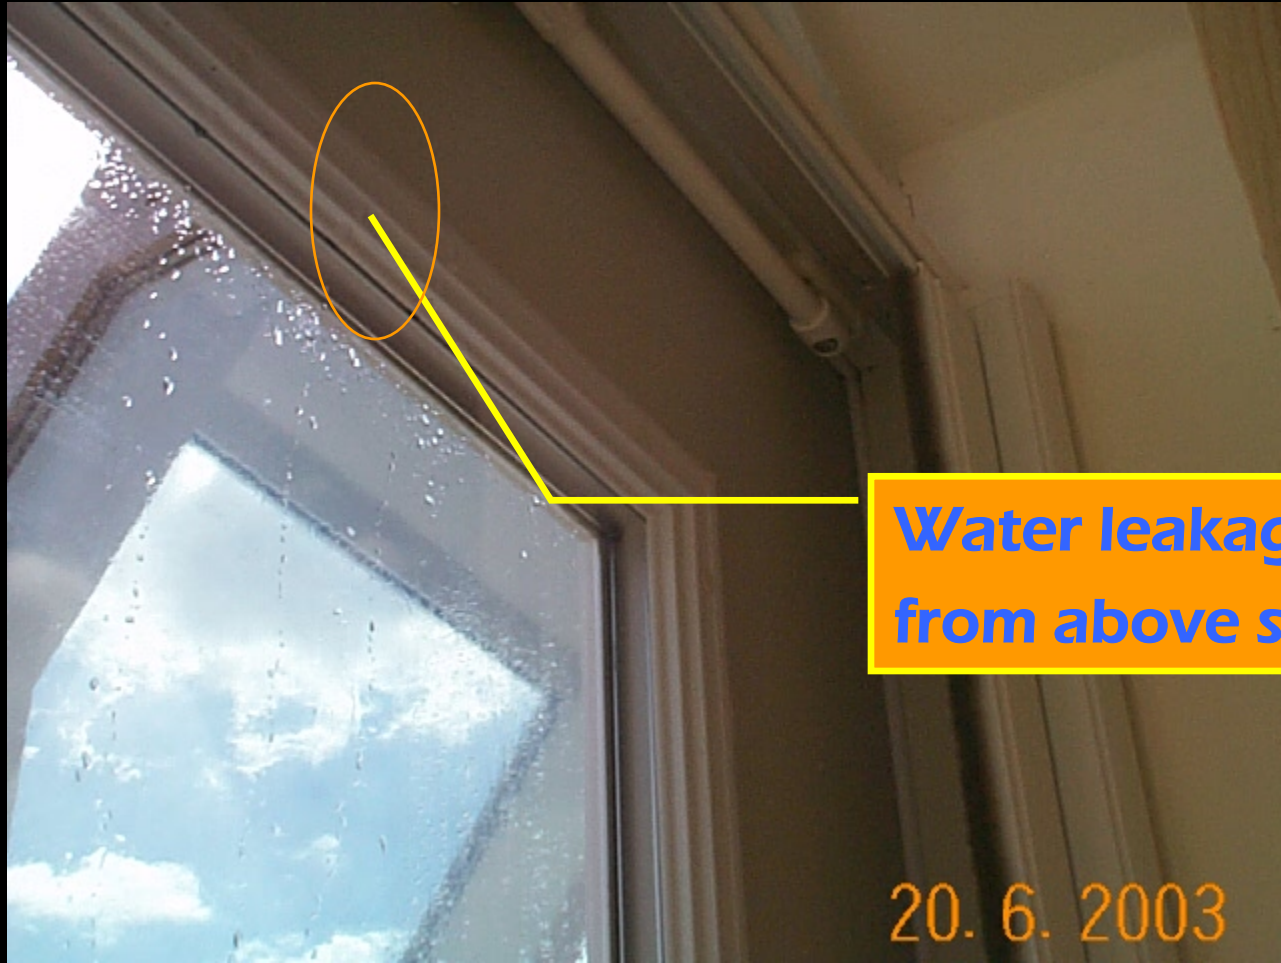
**Water leakage
from above slab**

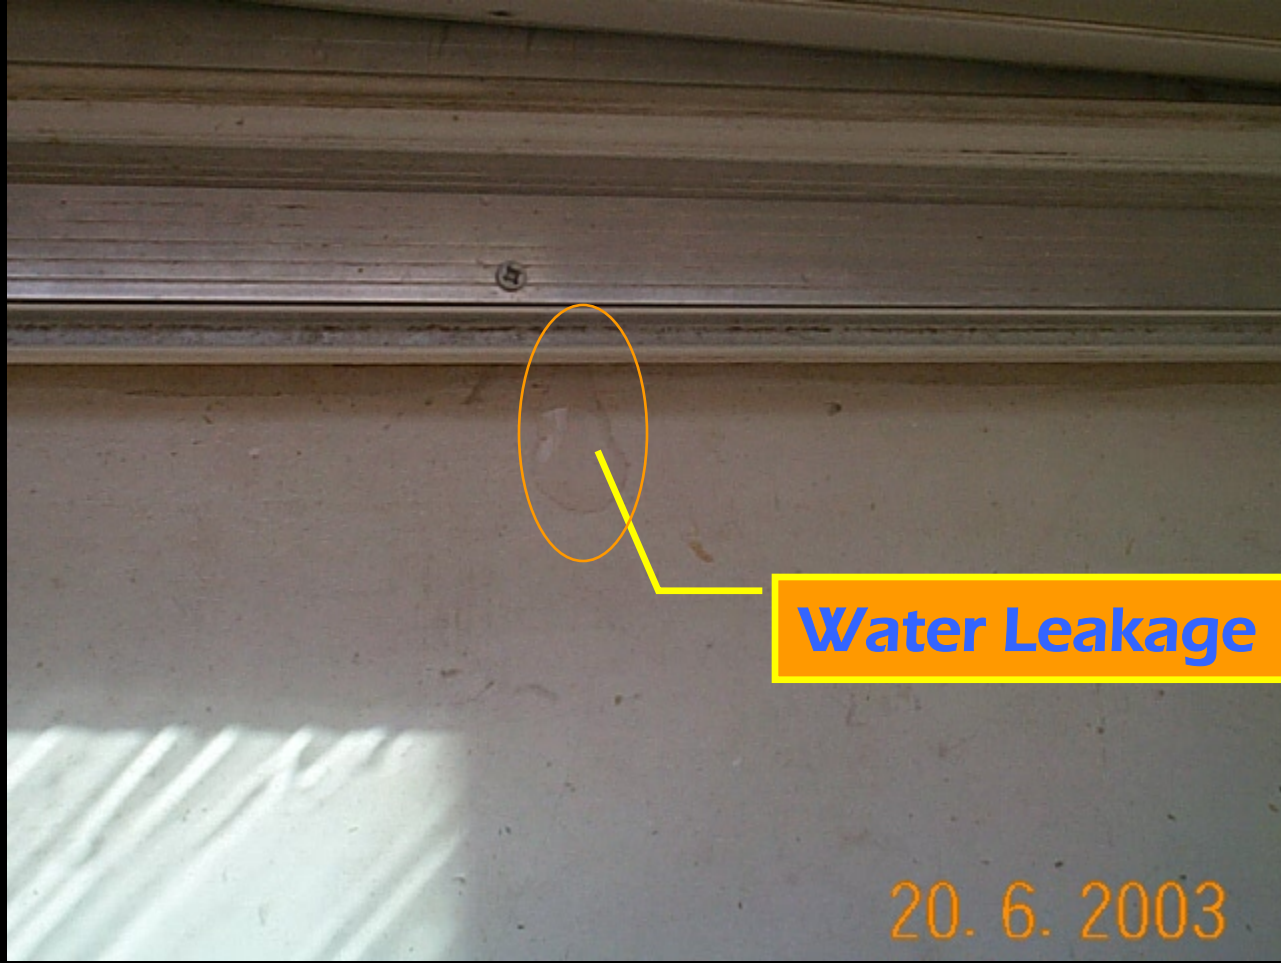
Water Leakage

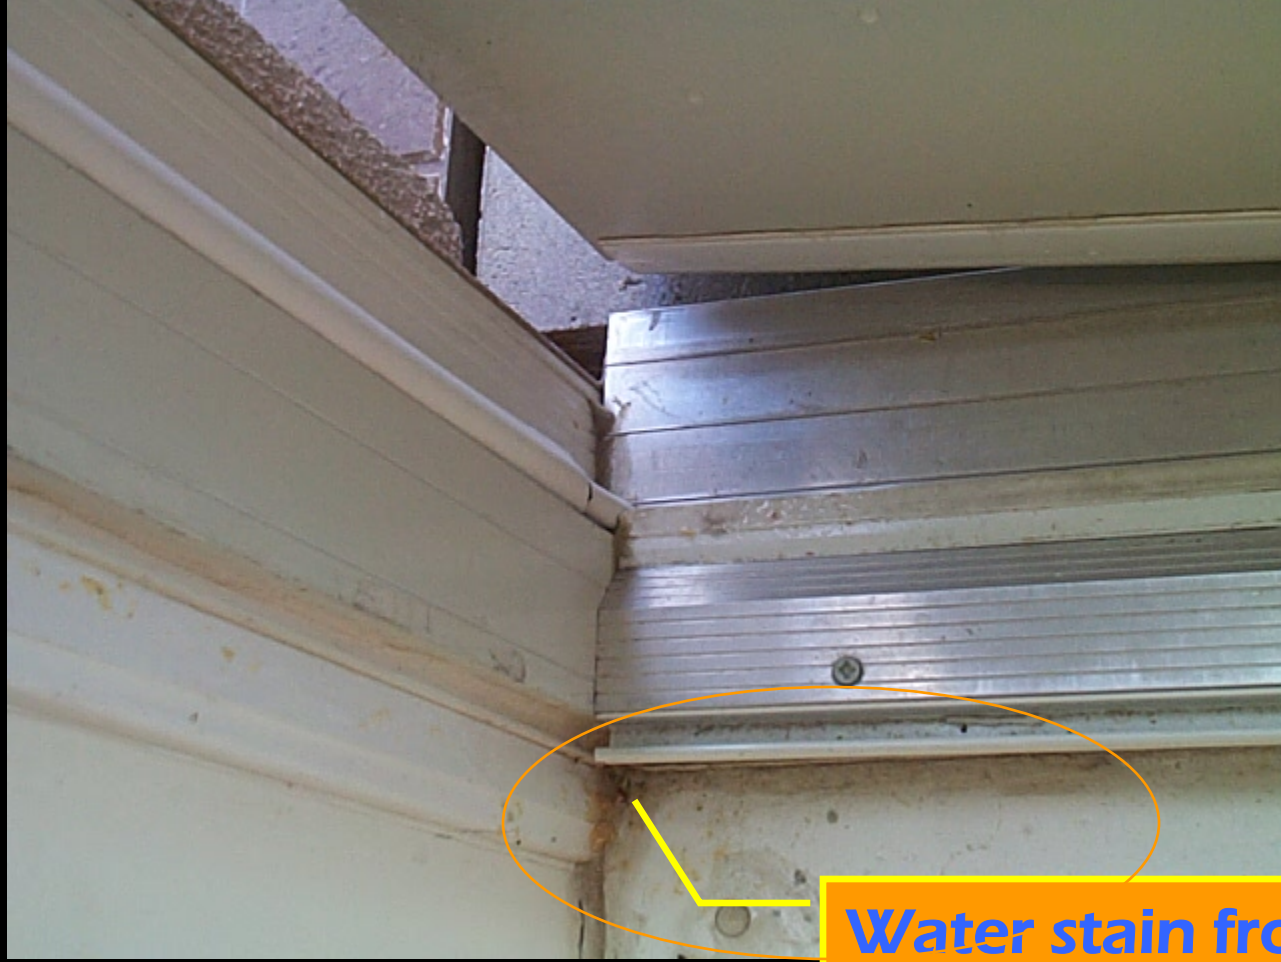
Water stain from prior nature testing

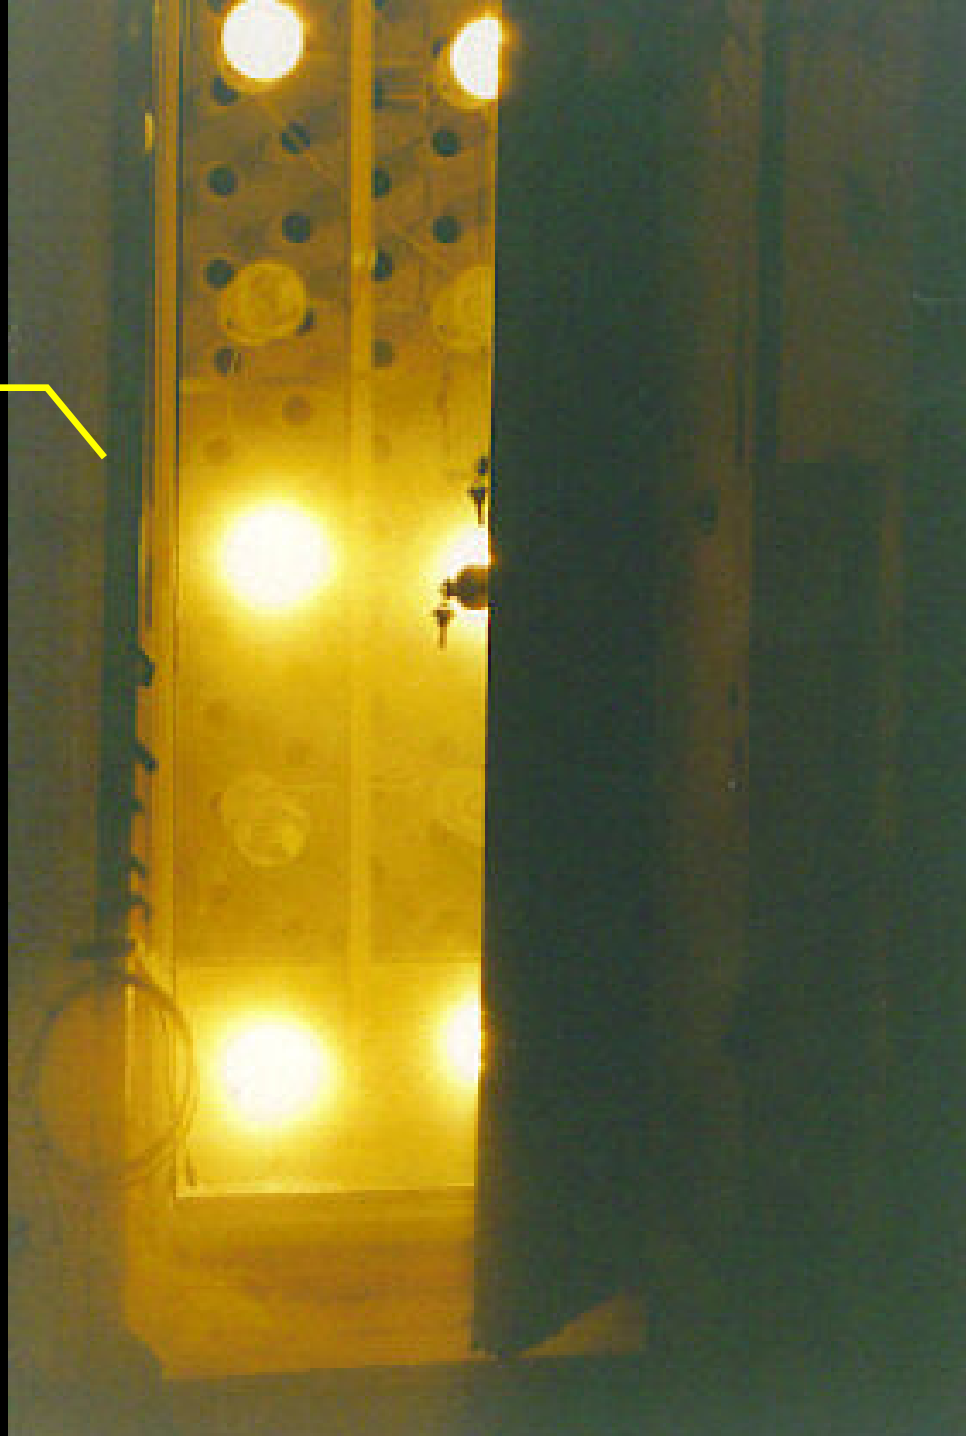
**Radiant
Heat**

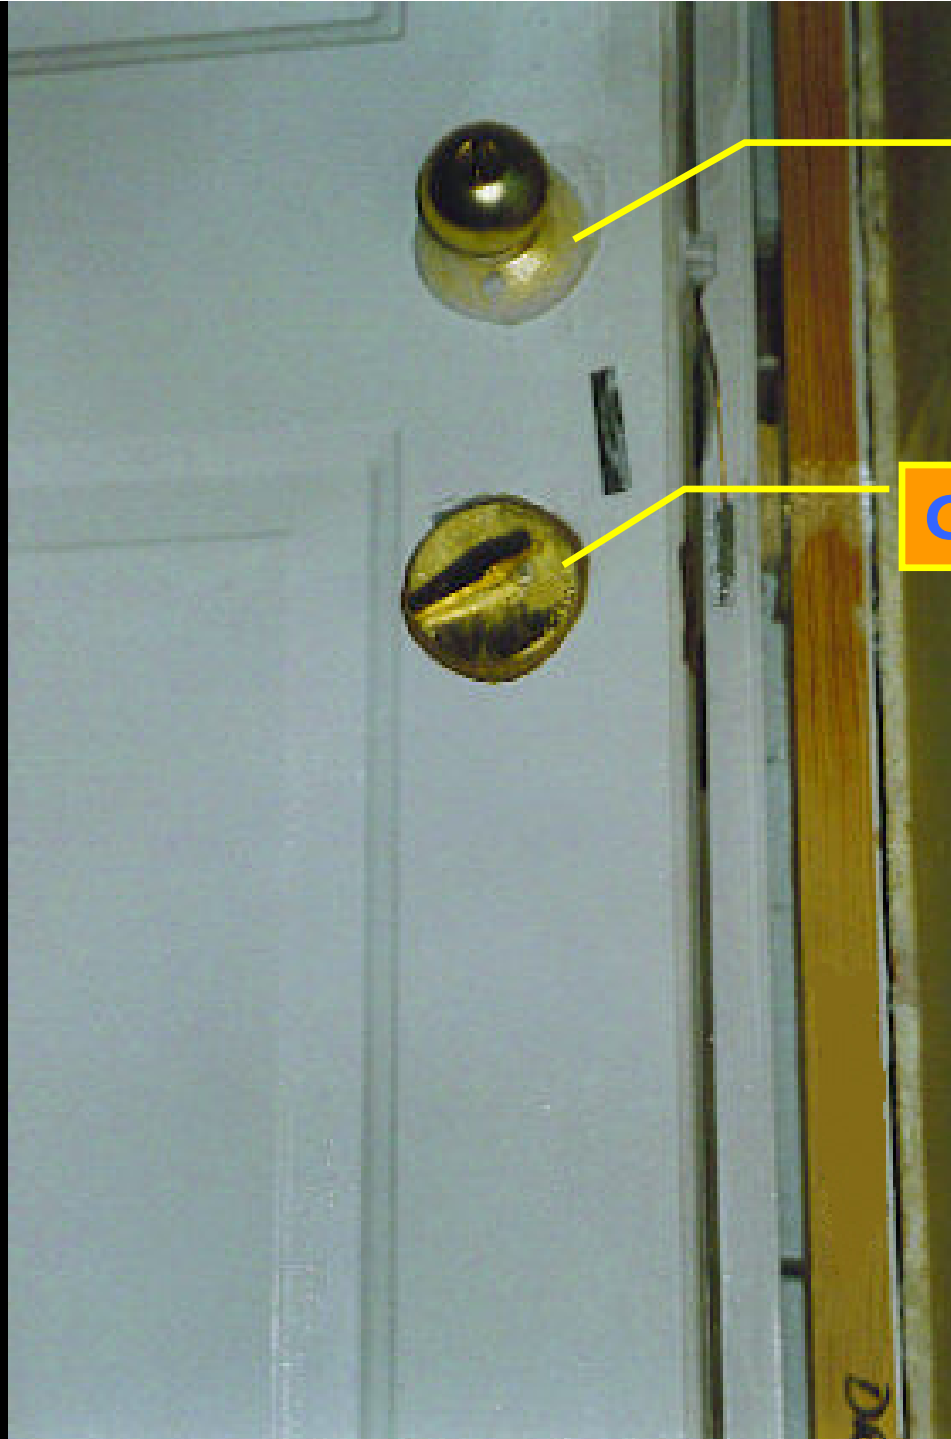
**Deflection
Gauge**

**Wind
Machine**

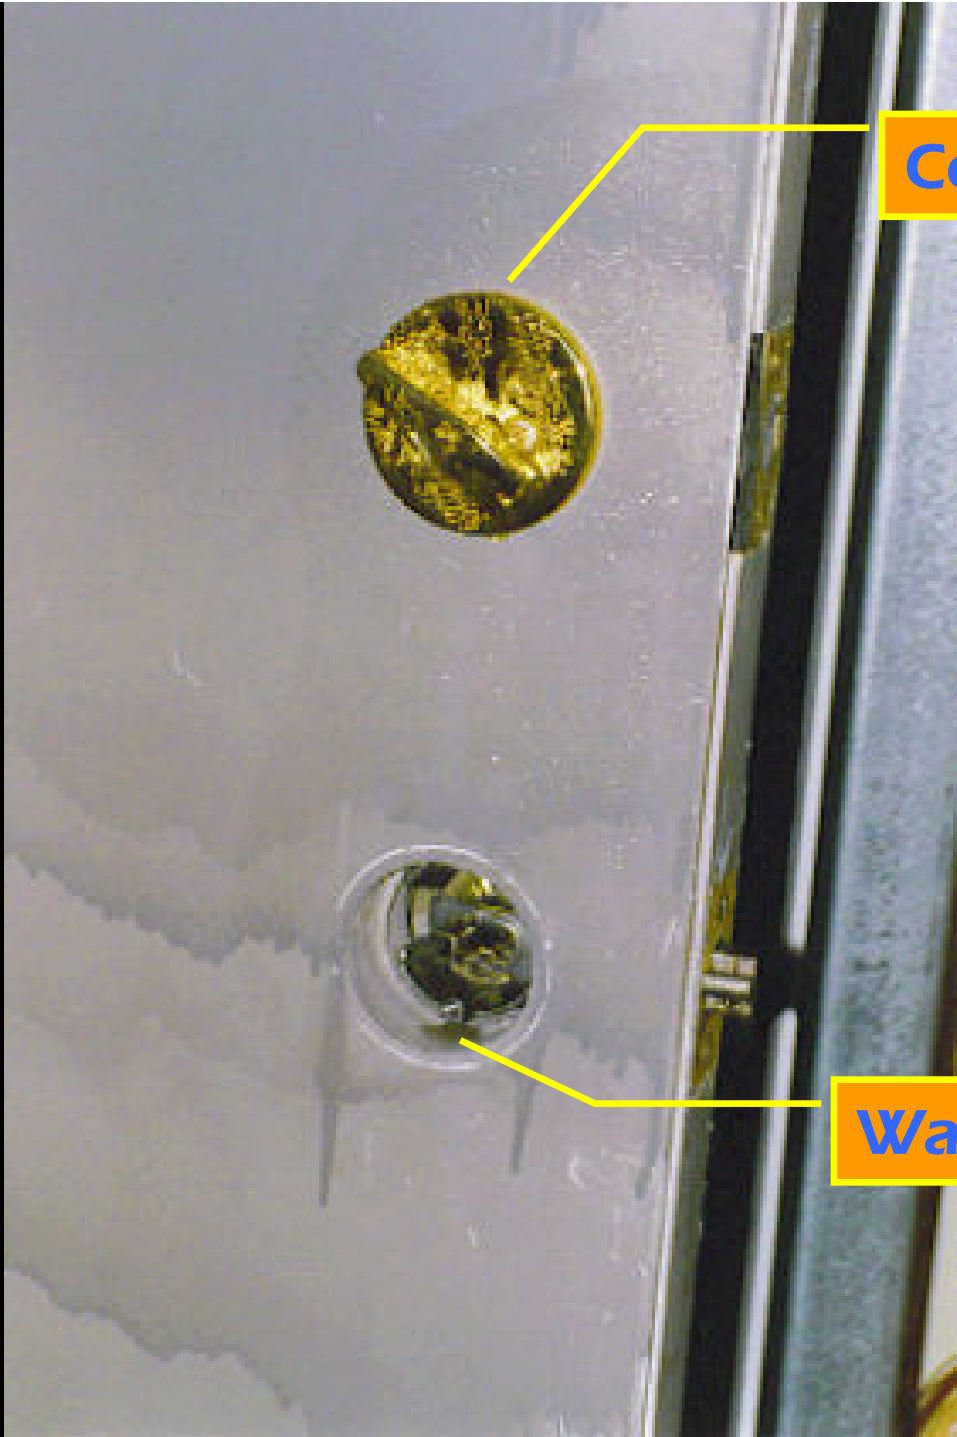
Frosting

Condensation

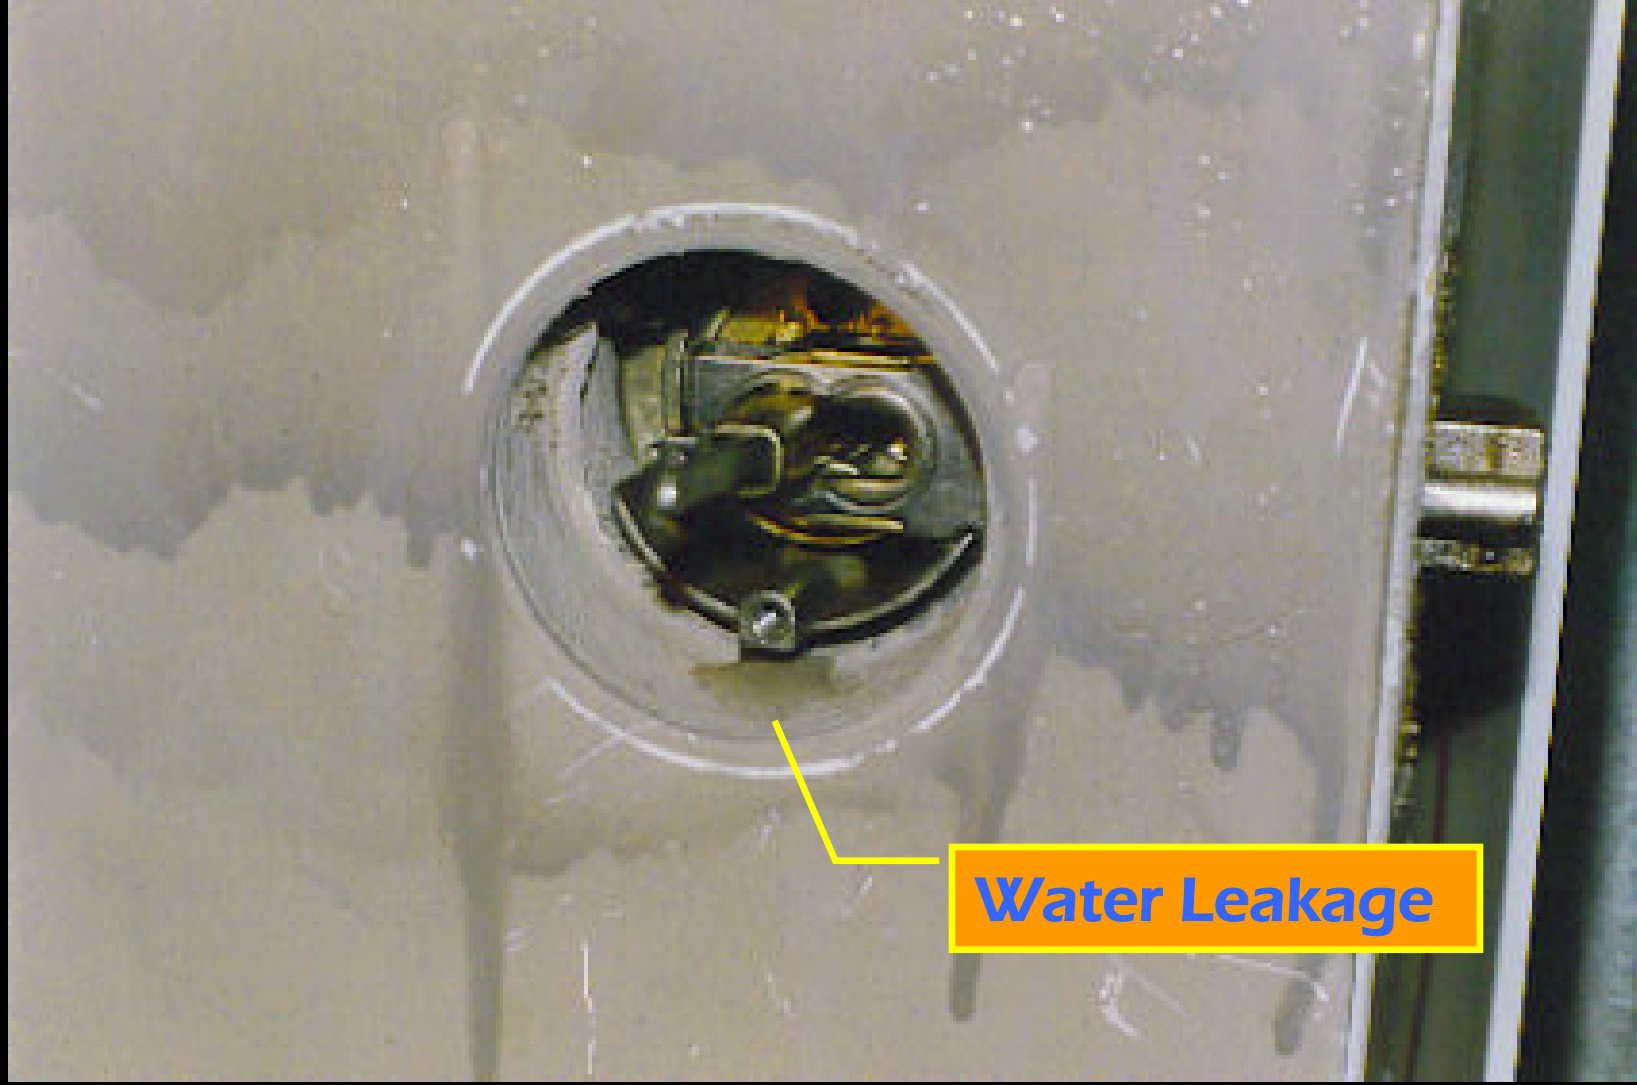
Condensation

Water Leakage

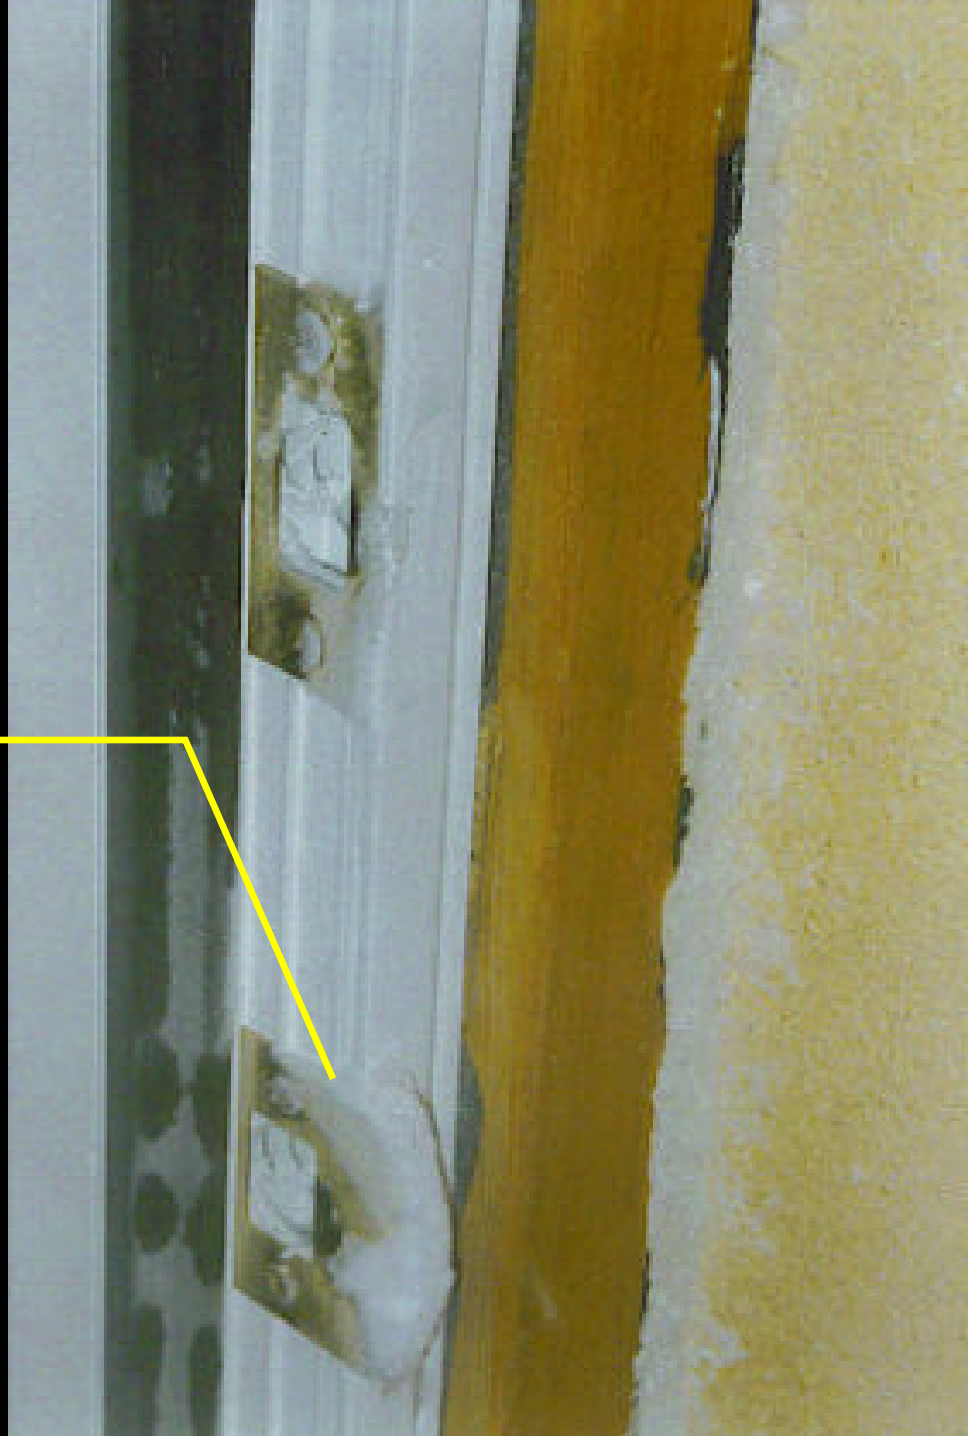
Frosting

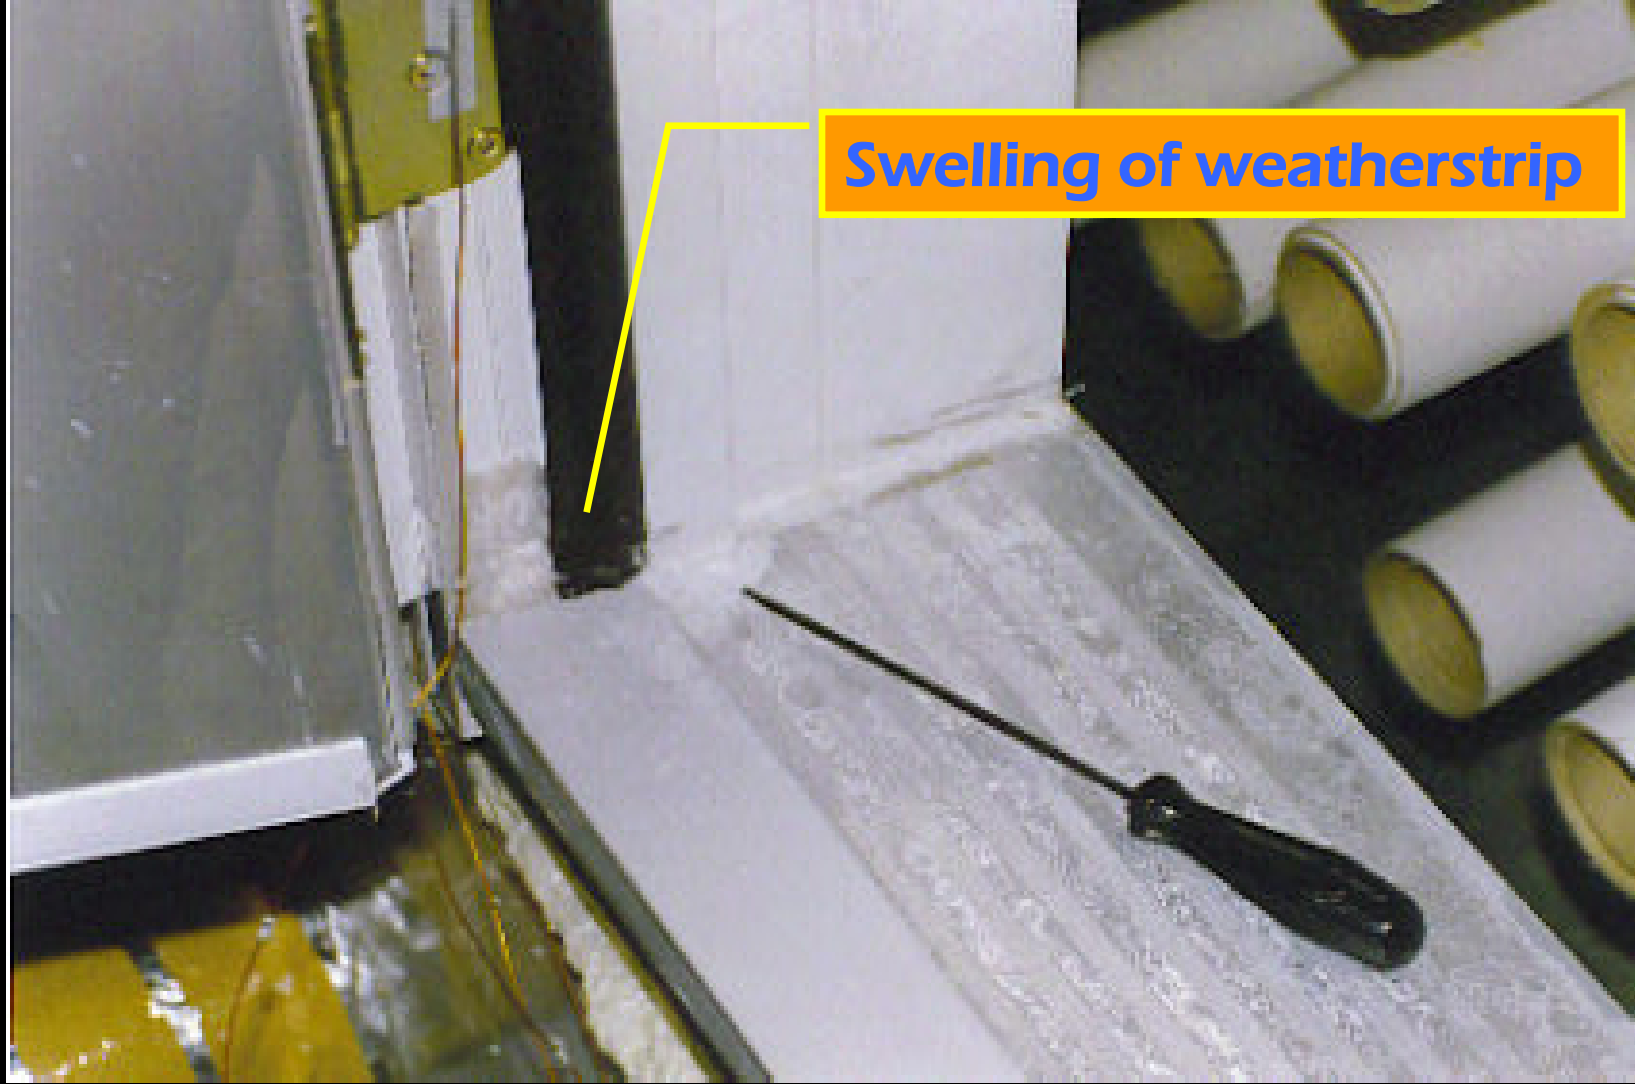
Swelling of weatherstrip

Ice trapped in weatherstrip fold causing further slab deflection

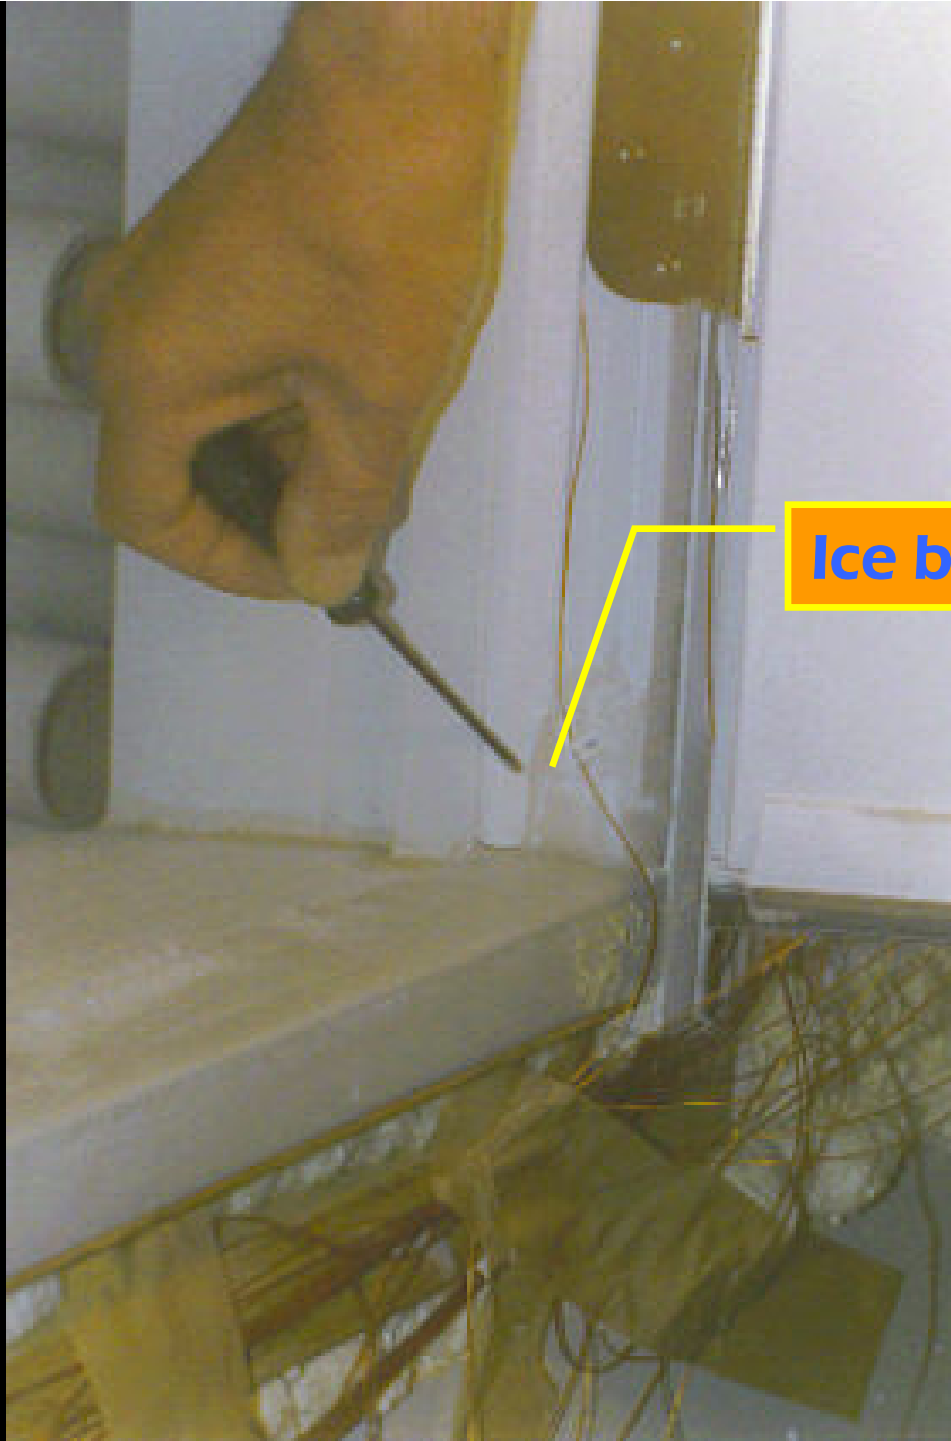
Ice buildup

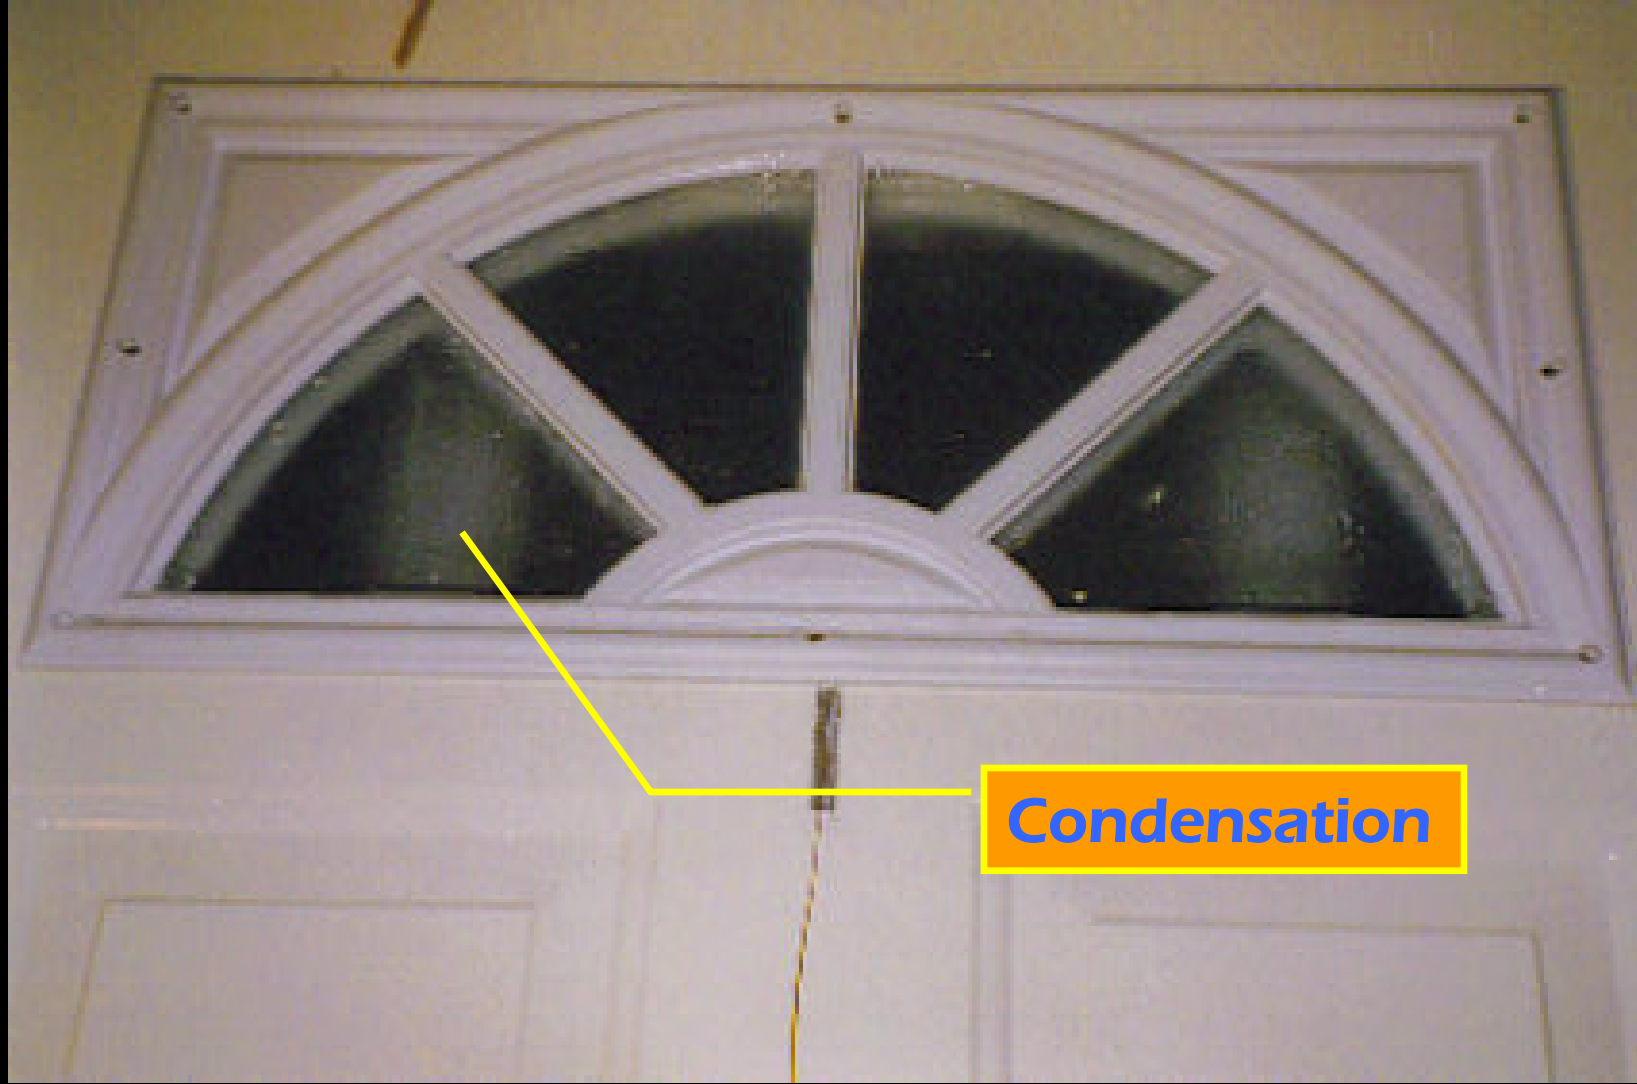
Condensation

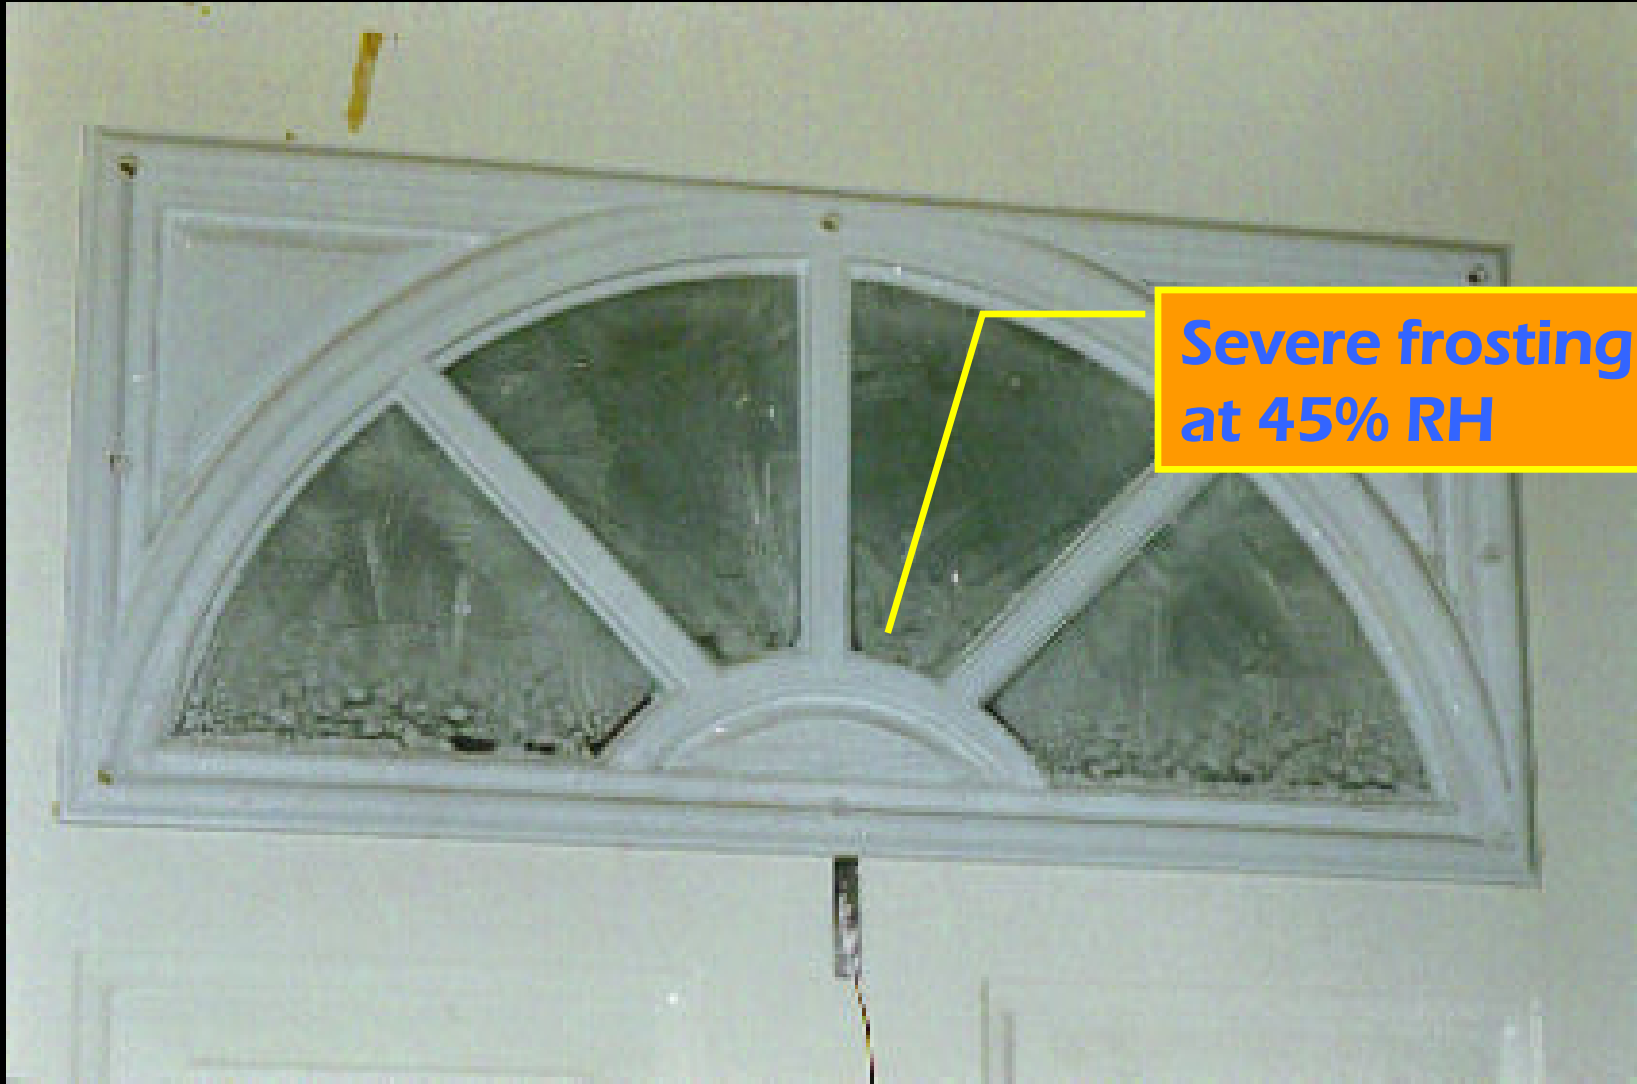
**Severe frosting
at 45% RH**
